# Maka hall at Yvoir : construction of a pool pass

# Aminthe Foundry at Yvoir : cascaded dams pass

# Dapsens Park : by-pass channel (River Bocq)

# Spontin village : removal of a weir (masonry-made spillway)

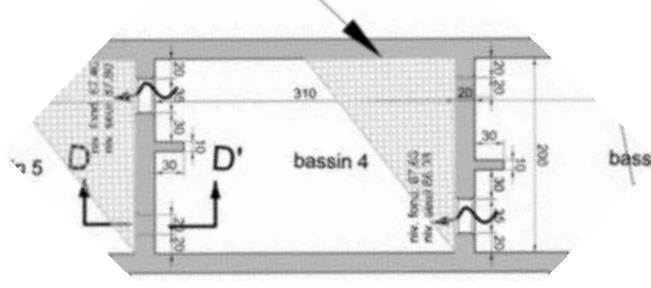
### **Technical arrangements**

- 8 falls 24-cm height (7 pools)
- Dimension of the notches: 0.30m wide ; 0.8m minimum water height
- submerged orifices: 0.2 X 0.2 m
- Reserved flow = 370 l/sec (= nominal pap flow)
- Reinforced concrete
- Coarse bottom substrate (rocks drowned in concrete)
- water level upstream almost constant (automatic valve)
- Control trap

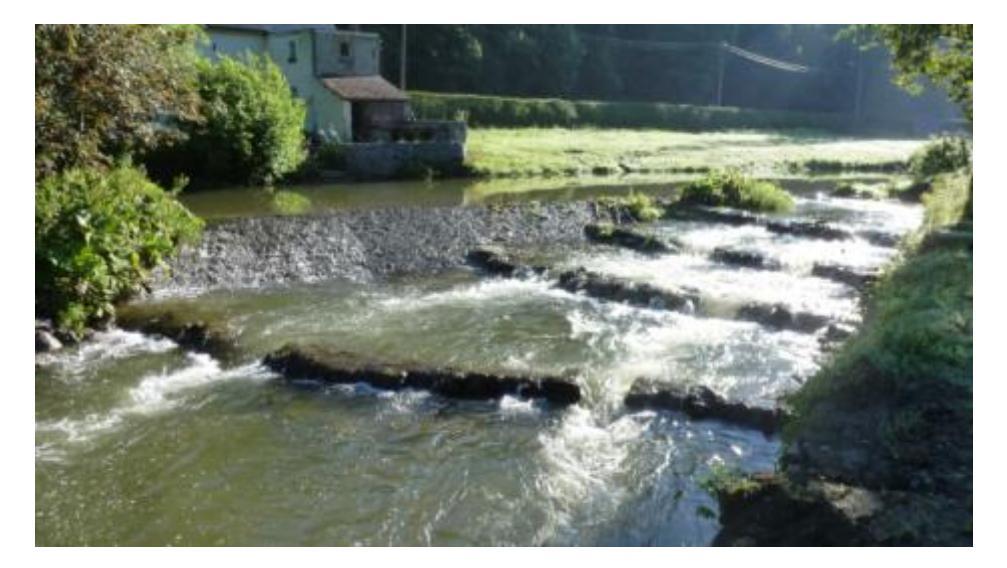
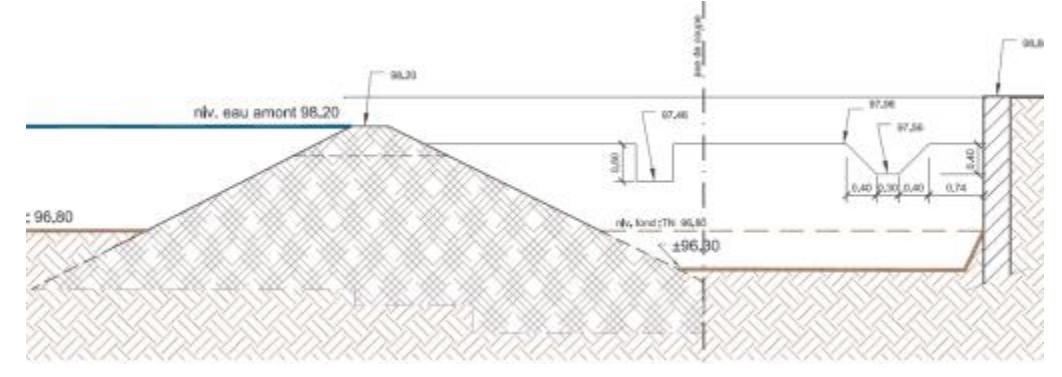
# Technical arrangement: cascaded dams of concreted rocks

7 falls, 20-22 cm height

2 notches (5 thresholds upstream) or 1 notch (2 thresholds downstream) per dam

Minimum water heights in notches: from 0.30 m (upstream) to 0,50 m (downstream)

Notch dimensions in side spillway had to be remade (flow coefficient Kd= 1.3 instead of classic values of Kd= 1.9 to 2.1)

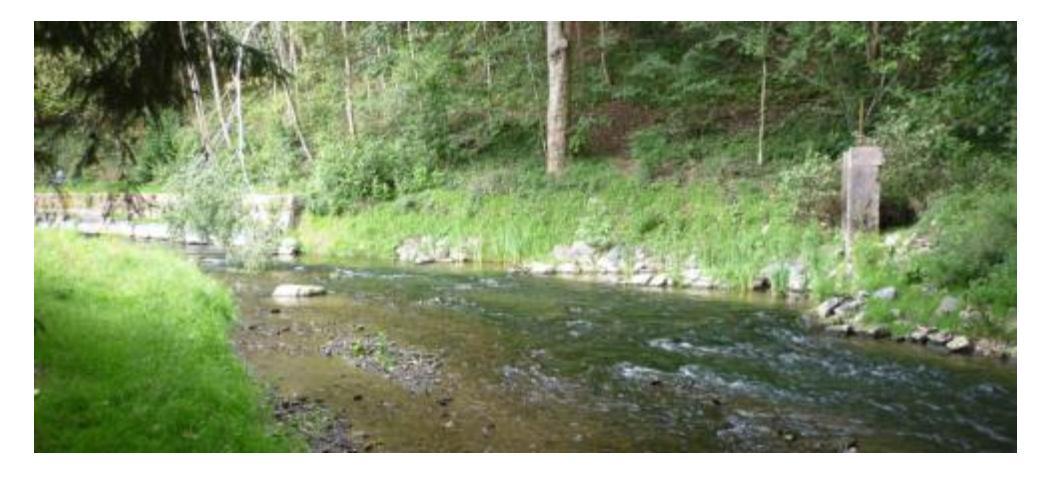
### **Technical arrangement:**

- Demolition of the masonry weir
- Stabilisation of the retaining wall
- Fish shelters through holes into the wall
- Building 2 bottom sills to reduce headward erosion
- Stabilising of banks along a 200-m distance (riprap groynes, banking and plantations)

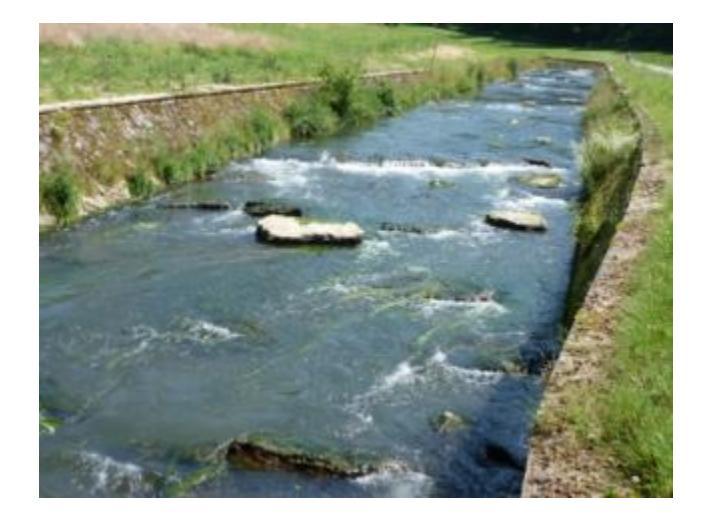
### **Technical arrangements:**

- step/pool scheme based on a cascaded construction including 23 boulder bars
- +35 cm rise of waterline
- Blocks fixed on top of the concrete apron or retained with steel corners
- Rock-filled berms of different sizes
- 200 T of pea gravels, for creating spawning ground
- 56 stone made fish shelter
- 140-m long and 50-cm high dike on the left side together with and excavation of a dry cut on the right side
